2017 TERMINAL 18 CAP INSPECTION REPORT

PORT OF SEATTLE TERMINAL 18

HARBOR ISLAND

March 14, 2018

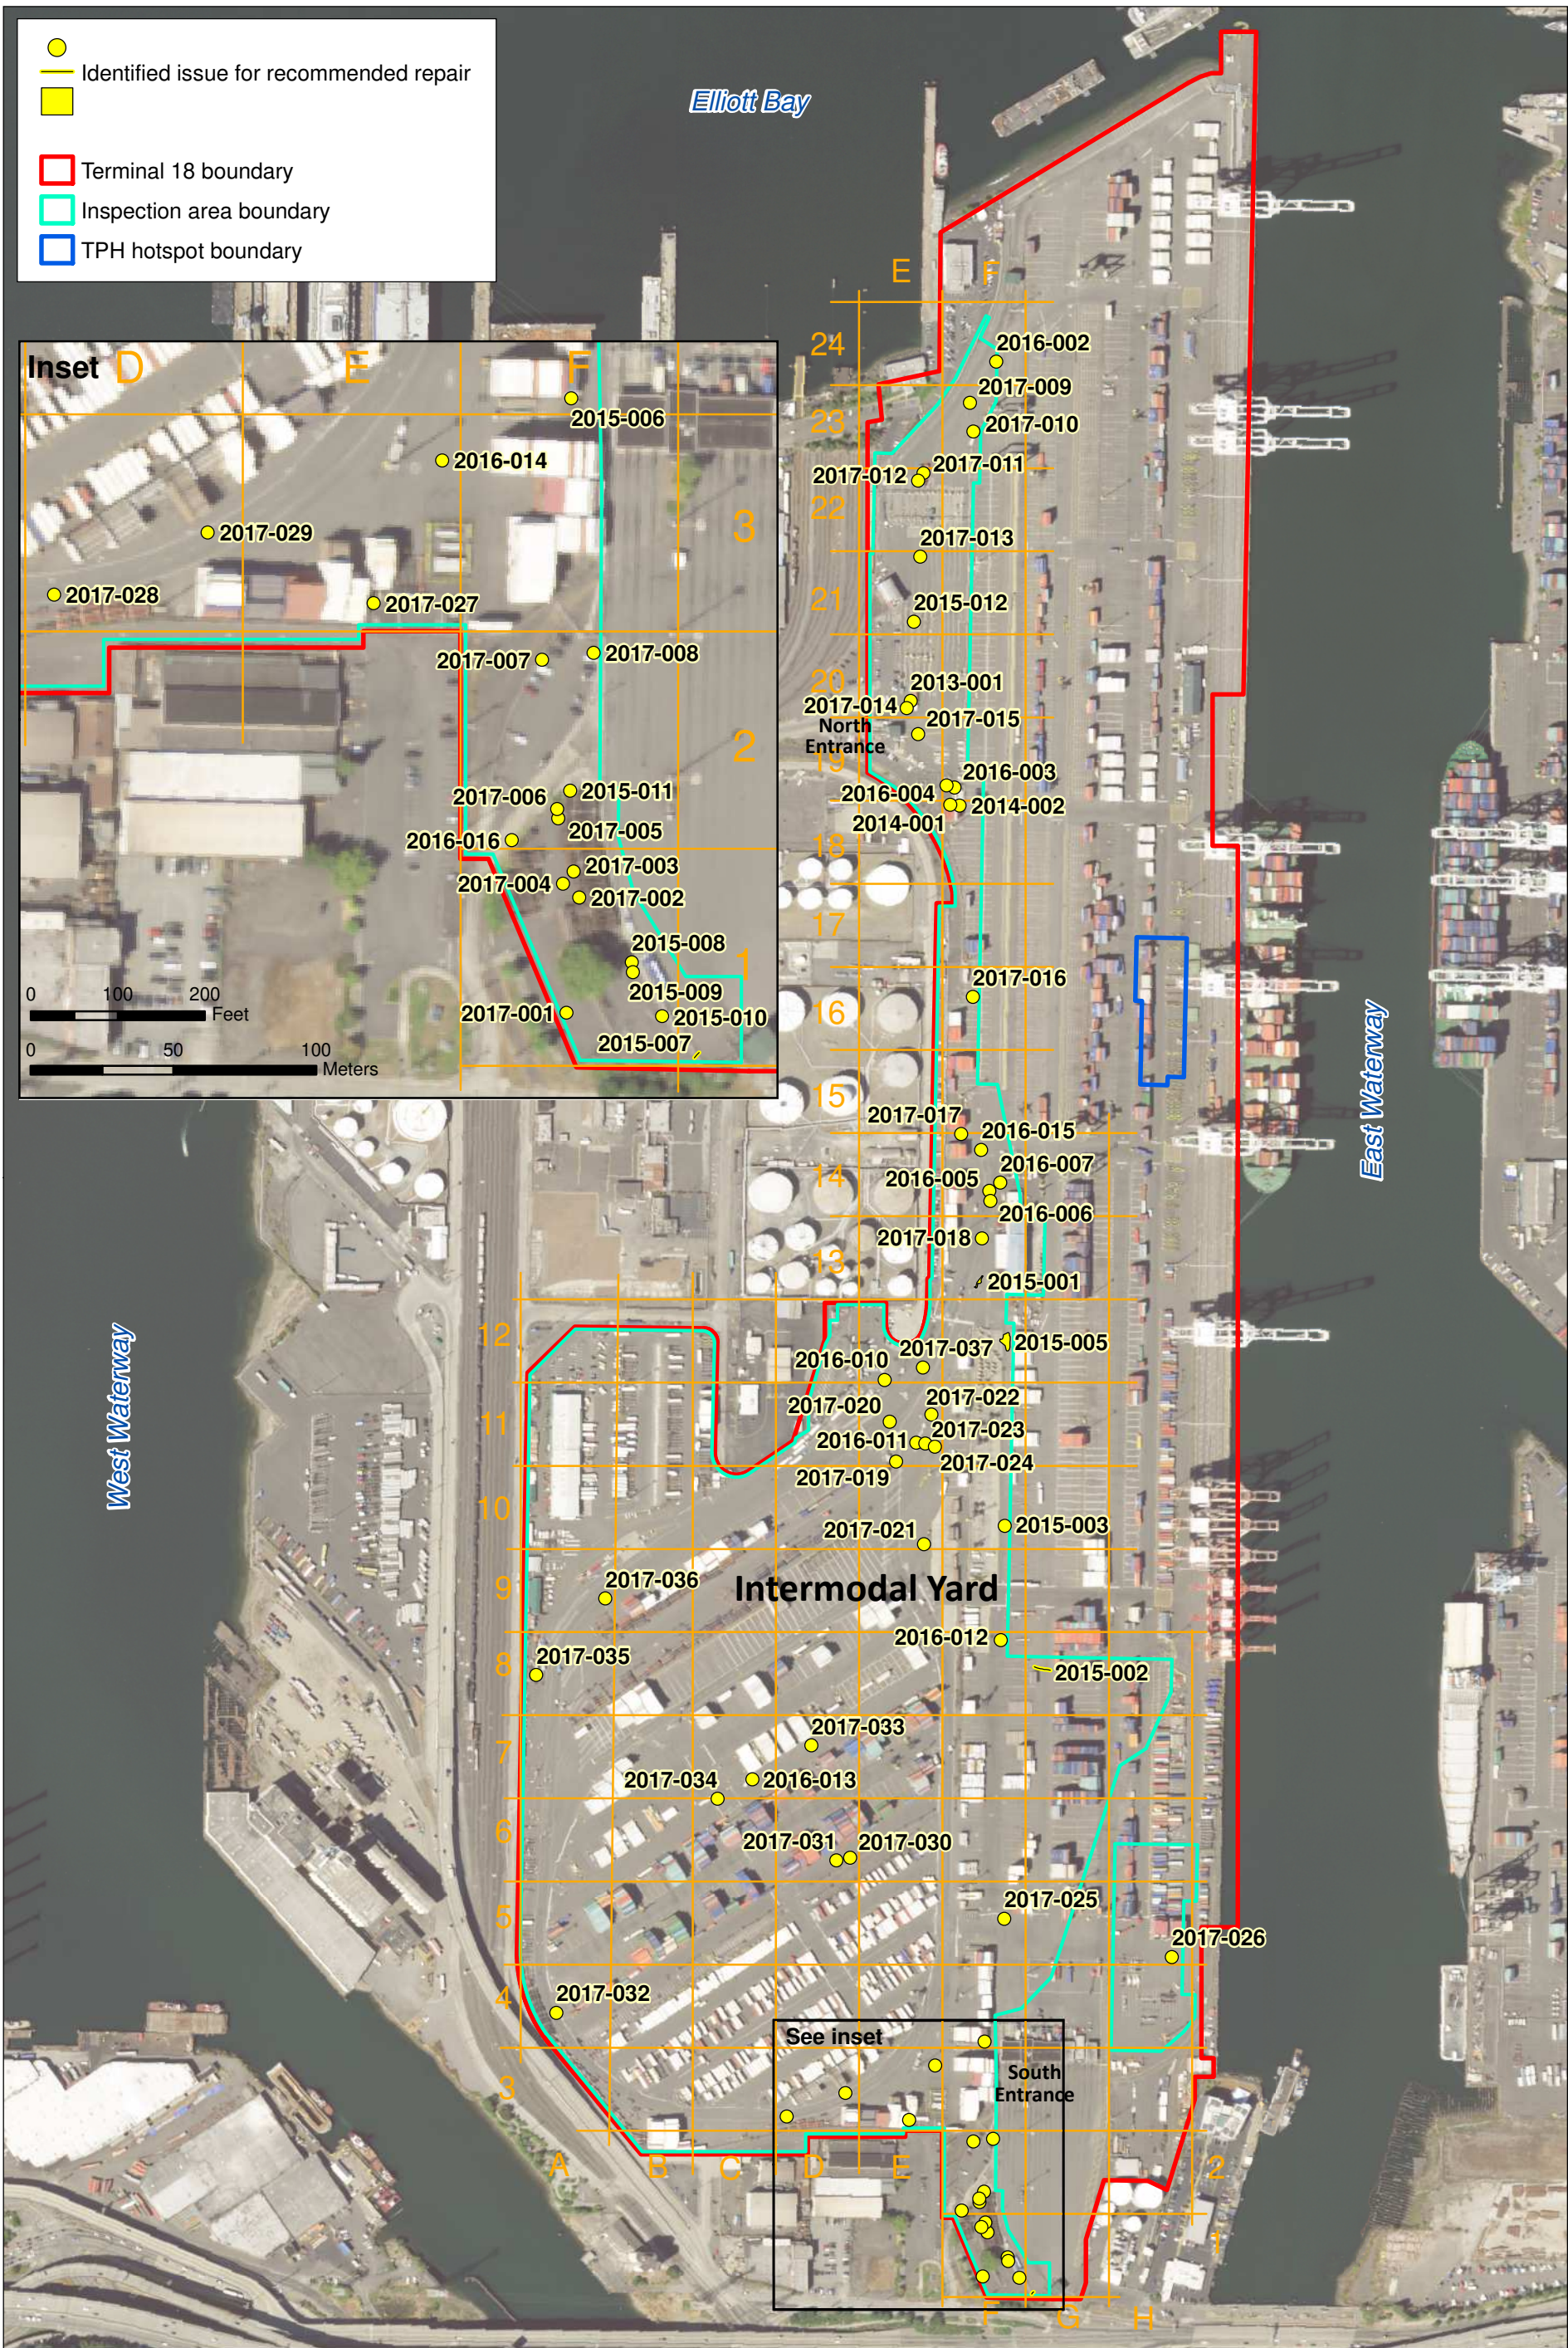
Map A-1. Conditions observed during 2017 inspection requiring maintenance or repair

An area of settlement with a depth of approximately 4 to 6 in. was observed near a catch basin structure in grid E-20 (2017-014 on Map A-1). Cracking was observed around the catch basin structure and in the area of settlement.

An area of approximately 500 ft² of settlement greater than 3 in. and alligator cracking was observed in grid F-12 (2015-005 on Map A-1), south of the maintenance shop. The settlement and alligator cracking in this area were also observed and documented in the 2015 and 2016 inspections.

- ◆ Divots were observed in an area of pavement damage approximately 12 × 6 ft in grid E-11 (2017-019 on Map A-1). A portion of the pavement has been saw cut but not yet repaired.

- ◆ Divots deeper than 3 in. were observed in an area approximately 60 ft in length in grid E-11 (2017-022 on Map A-1).
- ◆ Divots and pavement damage were observed in an area approximately 3 × 15 ft in grid E-11 (2017-023 on Map A-1). This area has been saw cut but not yet repaired. Alligator cracking was observed in the vicinity of this damage.

- ◆ Divots and pavement damage were observed in an area approximately 5 × 8 ft in grid E-11 (2017-024 on Map A-1). This area has been saw cut but not yet repaired.

- ◆ Divots were observed in grid D-3 (2017-029 on Map A-1). Additional cracking was observed in the vicinity of the damage.
- ◆ Divots first observed during the 2016 inspection were again noted during this inspection in grid E-11 (2016-011 on Map A-1). The divots extend over an area approximately 36 × 6 in. in size, and alligator cracking was observed in the vicinity of the divots.

A hole approximately 3 × 3 ft was observed in the pavement in the cap area south of the secure yard in the vicinity of the south entrance (grid F-2 on Map A-1). The pavement in this area should be cleaned and patched.

A damaged bollard (a vertical barricade post painted yellow in grid E-20 near the north end of the scales at Gate 4), previously noted in the 2010–2016 inspections, was observed again in 2017. While a repair had been attempted in 2013 (based on 2012 inspection recommendations), the 2013 inspection observations noted that the bollard appeared to have been re-damaged by vehicles, causing a gap at the point where the structure penetrates the asphalt cap. Damage to this bollard appears to be a chronic issue.

In grid F-10, a manhole with broken pavement around the perimeter was observed (2015-003 on Map A-1). This damage was originally identified in 2015 and should be repaired. A second manhole with broken pavement around the perimeter was observed in grid F-8 and should also be repaired (2016-012 on Map A-1); this damage was first observed during the 2016 inspection. Additional pavement damage was observed around catch basin structures in grids F-2, E-22, F-16, and F-14, and manhole structures in grids A-9, C-6, and E-12.

At both of these locations, the pavement and base course should be removed and replaced, as indicated in Section 5.2.2 of the CIR (RETEC 2006), during the upcoming dry season.

The bollard in grid E-20 shows evidence of recurring damage that has caused a gap at the point where the structure penetrates the asphalt cap. This gap may allow water to infiltrate underlying soils. The bollard should be repaired by placing new asphalt around the base. Because repeated damage to this bollard has been observed, some sort of replacement/alternative protective structure (e.g., ecology block) should be considered.

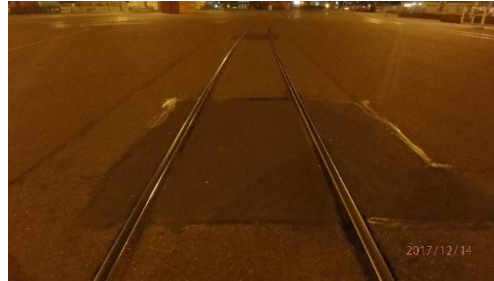
ID ^a	Grid Location ^b	Condition	Identified Maintenance Condition from Cap I&M Plan	Observed Maintenance	Easting	Northing	Photo
2016-009	E-11	cracking around rails in area approximately 4 × 8 ft; damage surrounded by alligator cracking	surface cracking; surface damage	area repaved and edges of new pavement sealed	1266112	214934

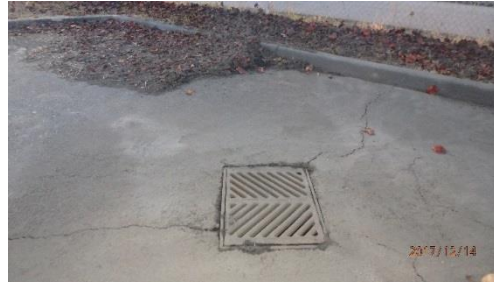
2016-016	F-2	partially blocked storm drain inlet (ponding)	standing water	debris cleared from catch basin inlet (see Appendix A)	1266280	212509

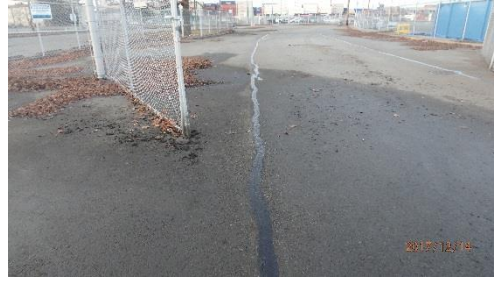
2015-007 (L15-30) ^c	G-1	linear crack penetrating cap	surface cracking	most of crack has been sealed since last inspection (see Appendix A)	1266496	212261
